North Division Street Hydro Facility Rehab Phase 2 - Construction photos
Hydro Project P-8949 - NY
NATDAM ID No. NY 11430

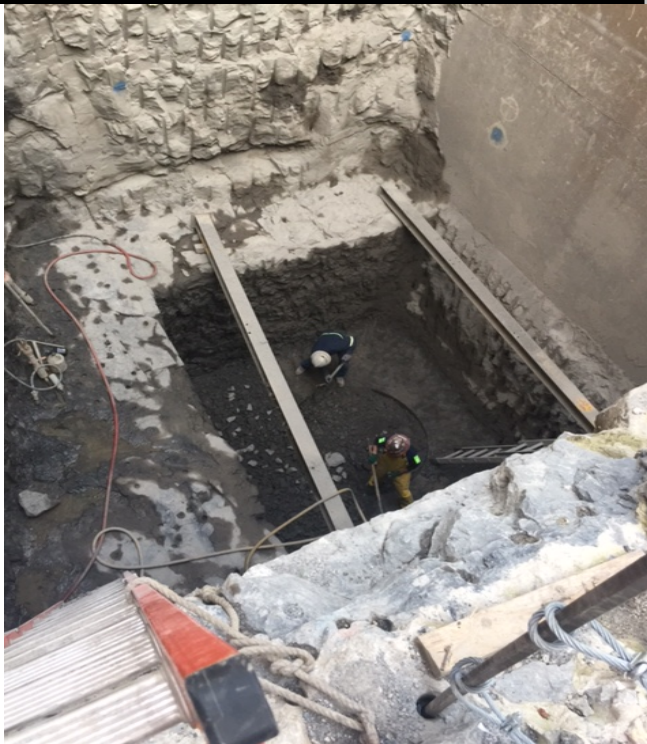
The crew works on cleaning out debris from the lower pit (8-07-17).

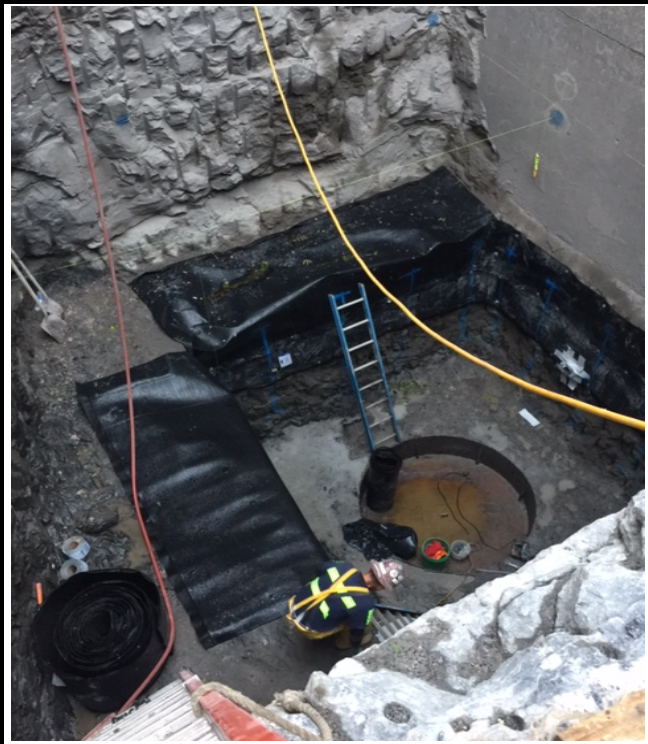
The crew has begun installing water board (8-08-17).

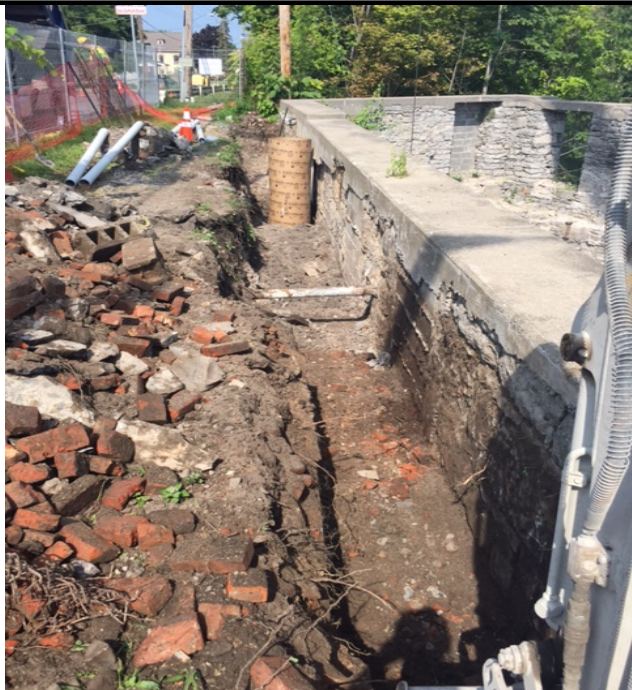
Electrical work has begun along the south wall (8-09-17).

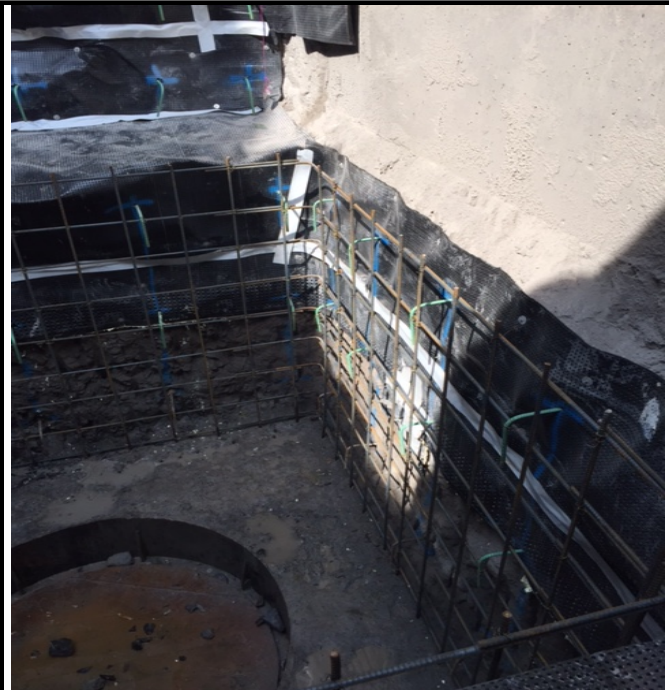
Rebar has been installed in the lower pit (8-10-17).

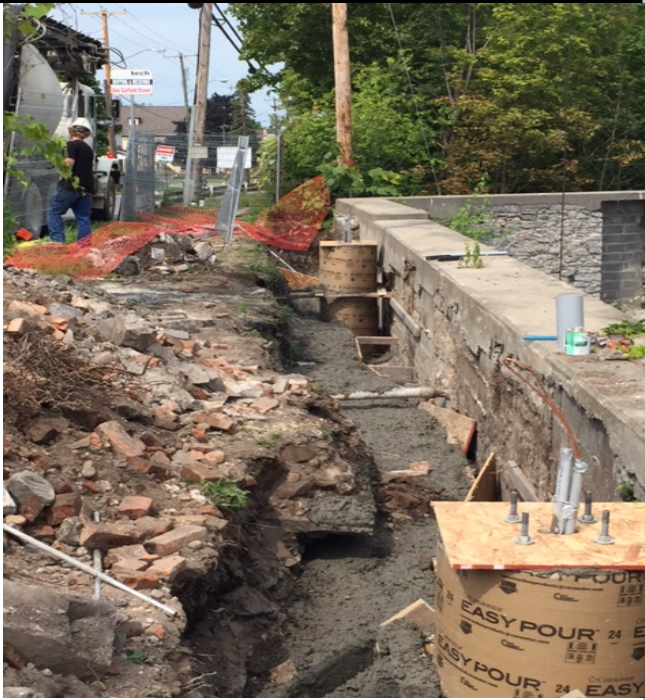
Concrete has been placed in both the trench and the Sonotubes (8-11-17).

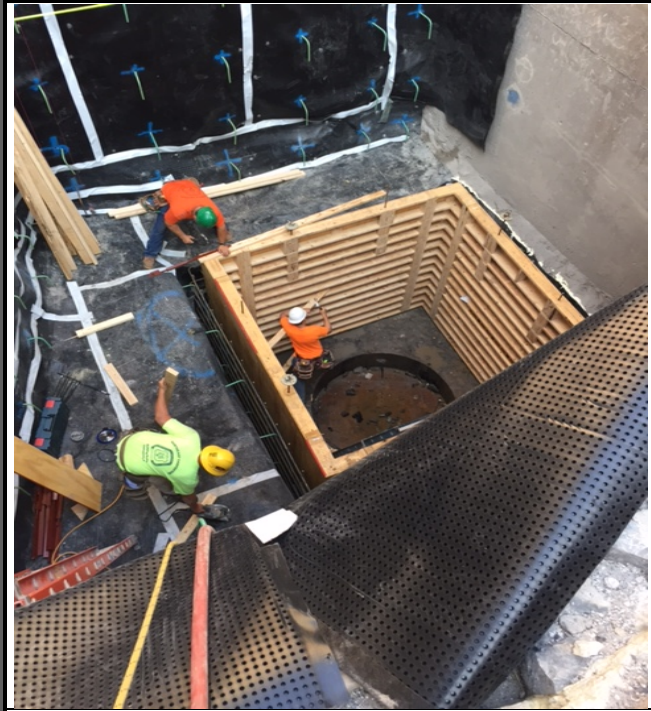
The Carpenters are working on installing the formwork in the lower pit (8-12-17).
