Phase I Environmental Site Assessment

**60 Canoga Street
Auburn, New York**

CHA Project Number: 23348

March 13, 2012

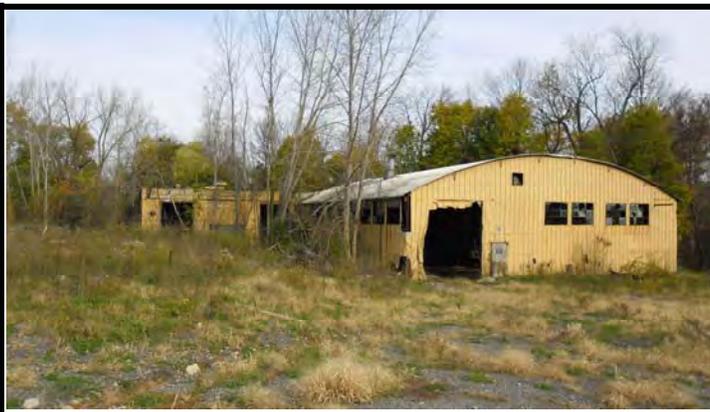
Photograph 1. Looking north at the Property.

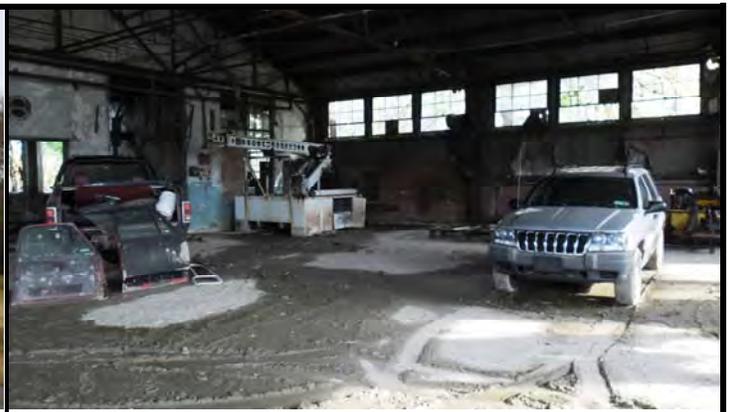
Photograph 2. Storage inside the structure.

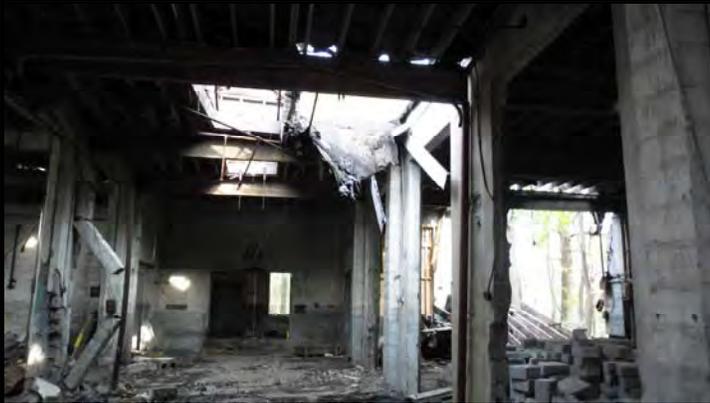
No large areas of stained soils or surfaces were observed on the Property at the time of the site reconnaissance, except some staining on the concrete floor however this is expected to be water staining resulting from the leaking roof. A concrete slab with observed staining is located on the adjacent former Tele-K site located west of the Property.

Photograph 3. Middle portion of the structure including compromised roof.

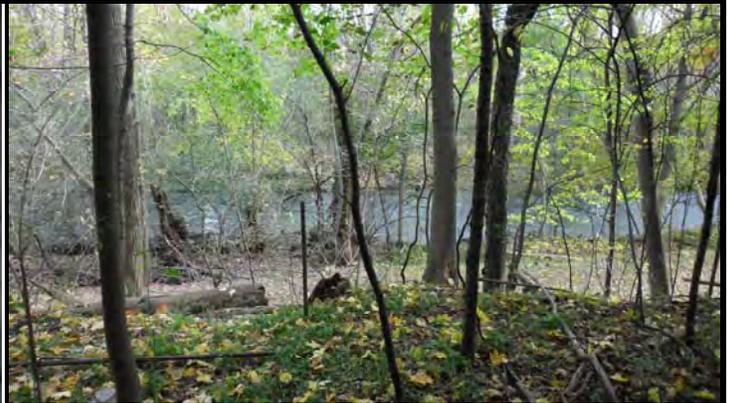
No current discharges were noted on the Property at the time of the site reconnaissance. It is anticipated that stormwater runoff follows the topographic gradient which is generally to the east. There is a fairly steep slope located on the eastern portion of the Property, adjacent to the structure, which leads towards the Owasco River. Some slope erosion of the bank is noted and a silt fence has been established along the Owasco River.

Photograph 4. Looking east at the Owasco Outlet.

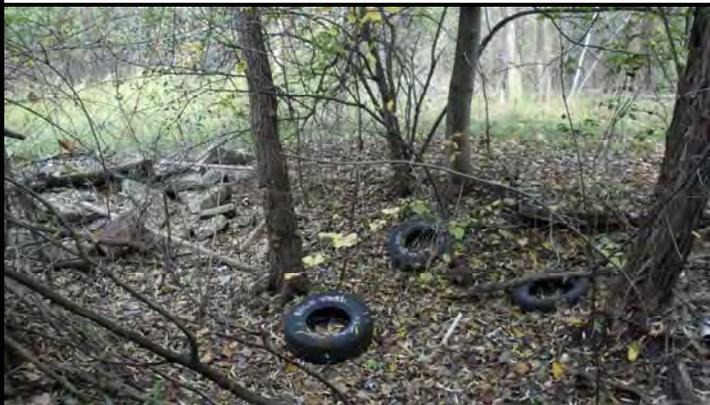
At the time of the site reconnaissance, CHA did not note any evidence of improper waste disposal on the Property, except various amounts of metal, tires, paper, metal and plastic debris, remnants of metal shelving and a ceramic toilet. Most of the waste is located east of the building on a slope leading towards the Owasco River. These wastes are not expected to pose any significant threat to the environmental integrity of the Property.

Photograph 5. Concrete and debris behind the structure.

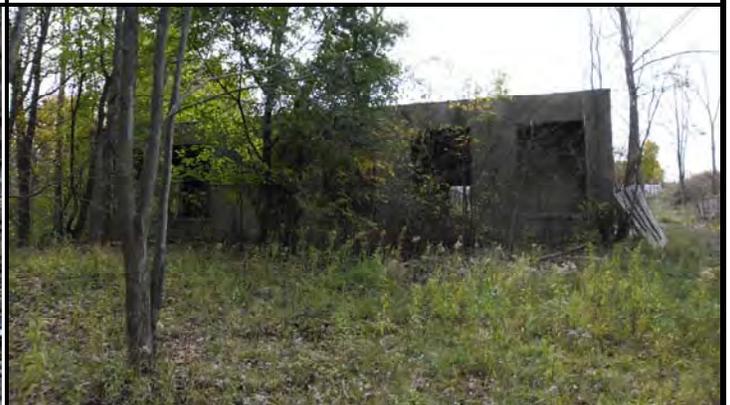
Photograph 6. Looking towards the structure from the rear of the Property.
