Soil Vapor Intrusion Sampling Report

Former Kalet Building
1-7 State Street
Auburn, New York

**RE: Soil Vapor Intrusion Sampling Report
Former Kalet Building – 1-7 State Street, Auburn, New York
AECC Project Number: 11-036**

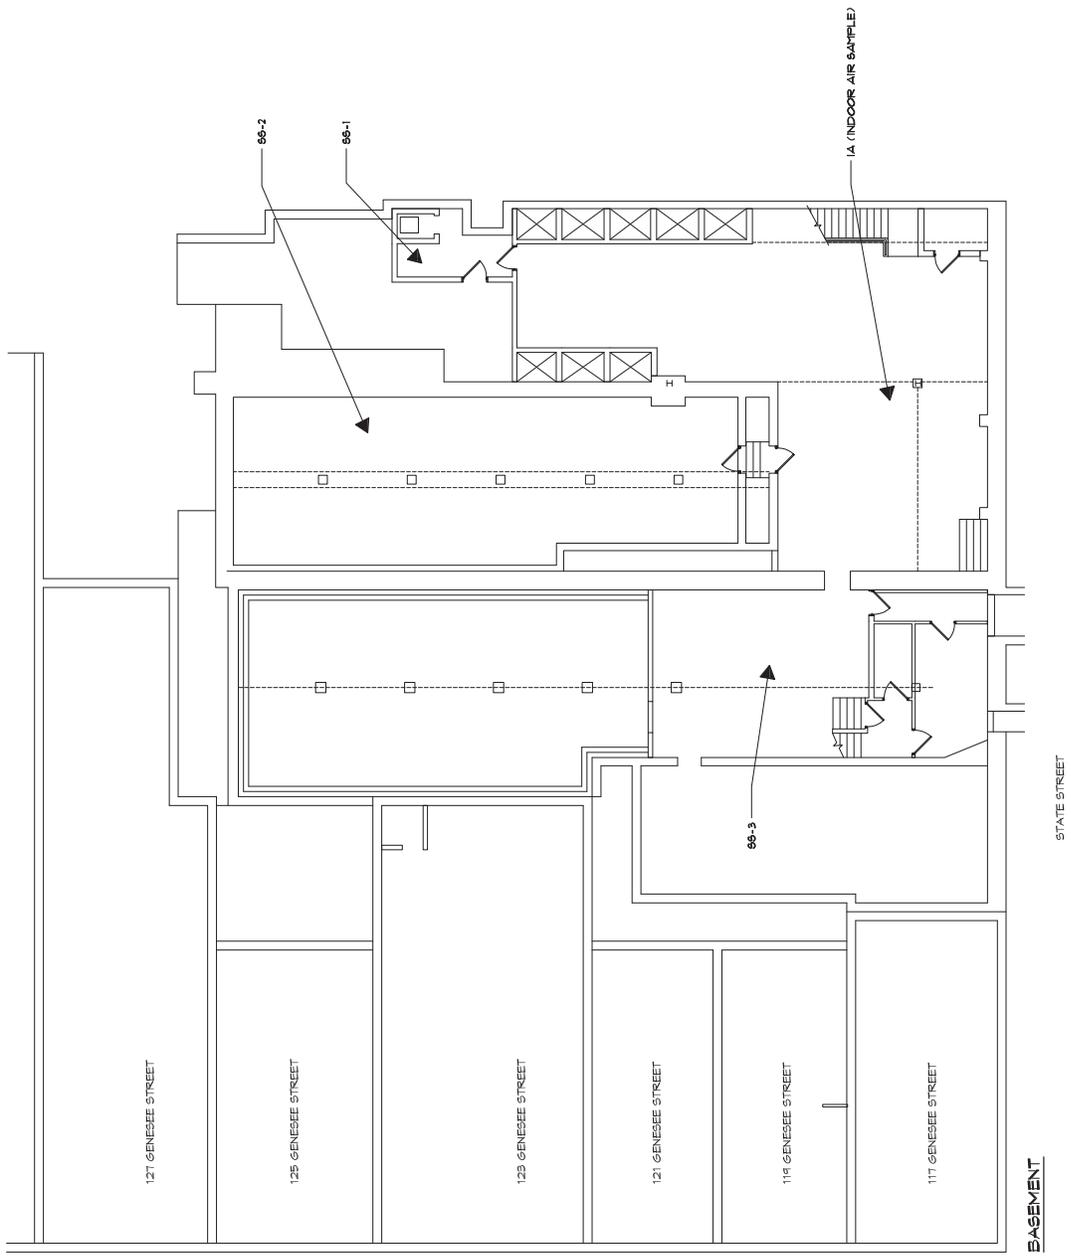
AECC Asbestos & Environmental Consulting Corporation 6296 Fly Road, Suite 2 East Syracuse, NY 13057	PROJECT NO.:	11-096	FIGURE	2	
	DRAWN:	FEB 2011	The Kalet Building Soil Vapor Intrusion Sampling Locations		
	DRAWN BY:	HHM	Basement		
	CHECKED BY:	JTI	1 State Street, Auburn, N.Y.		
	FILE NAME:

The sub-slab samples were collected from below the concrete slab in the basement of the building (Figure 2). At each sub-slab sample location, a hammer drill was used to drill a 5/8-inch diameter hole through the concrete slab. The thickness of the slab was approximately 6 inches thick at sampling locations SS-1 and SS-3. At sampling location SS-2, two (2) slabs were observed; the top slab which was approximately 3 inches thick and the bottom slab which was approximately 15 inches thick.

The building is a three-story, vacant building (basement included). The basement consisted of a concrete slab ranging in thickness from approximately 6 to 18 inches. The condition of the slab was fair, with few cracks and penetrations observed in the areas that were safely accessible. Due to the

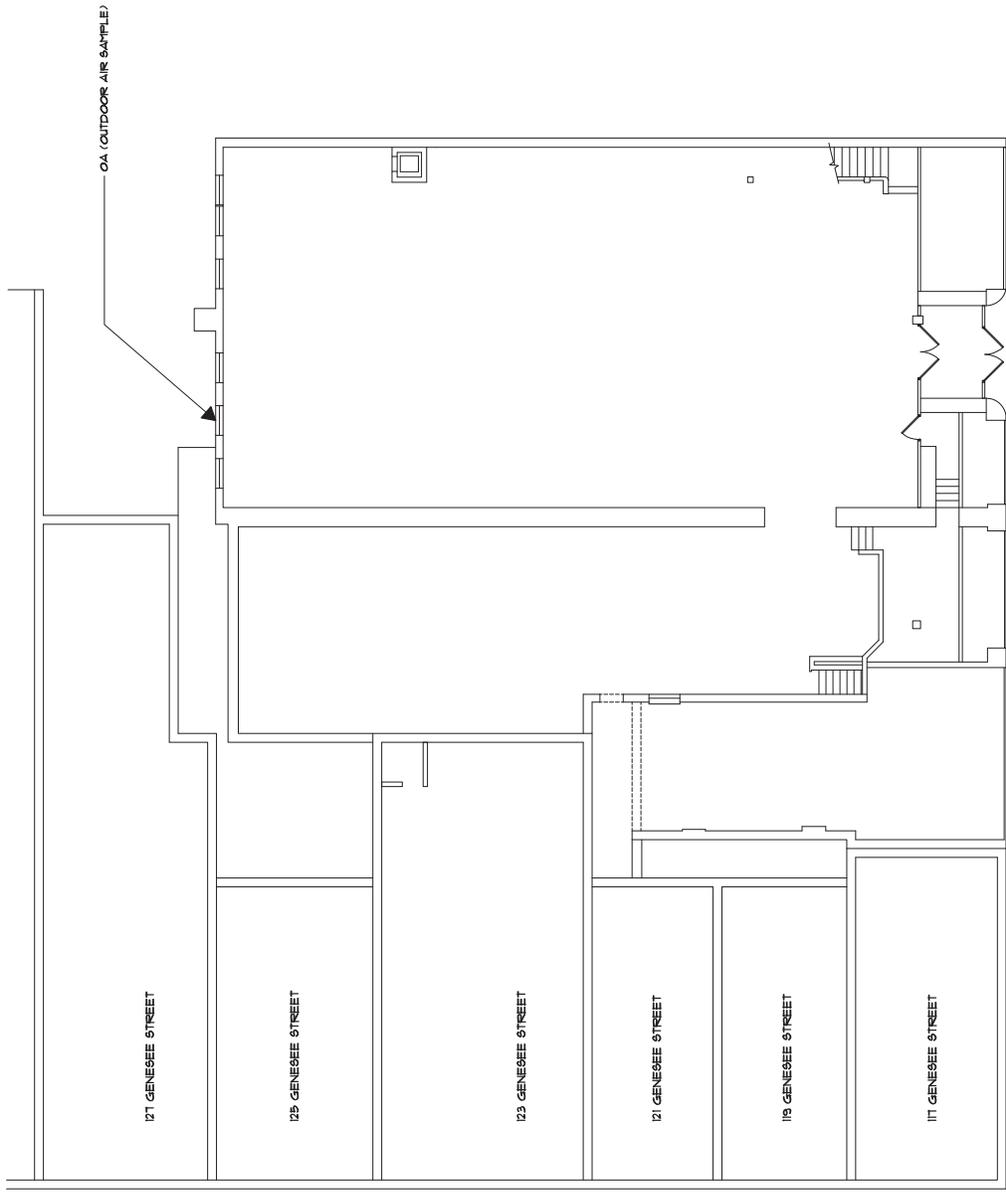
PROJECT NO.:	11-036	FIGURE	3	
	DRAWN:	FEB 2011	The Kalet Building Soil Vapor Intrusion Sampling Locations First Floor 1 State Street, Auburn, N.Y.		
	DRAWN BY:	HHM			
	CHECKED BY:	JTI			
		FILE NAME:

The indoor air sample (IA) was placed in the basement at approximately 4 feet above the floor. The outdoor air sample (OA) was placed outside a 1st floor window on the west side of the building (Figure 3). The set-up of the IA and OA samples consisted of connecting pre-calibrated regulators to 1 liter, stainless steel, Silonite coated, MiniCan sampling canisters.

The first floor consisted of several large rooms and exterior windows. Several of the windows were damaged, allowing air to flow into and out of the building. The City had been storing a gasoline powered generator inside the building on the first floor for a power supply. On the day of the SVI sampling event, the generator was started inside the building by City representatives, but then moved outside the building upon AECC's request. The generator was placed immediately outside the front entrance to the building. A general screening of the air on the first floor registered no PID readings.

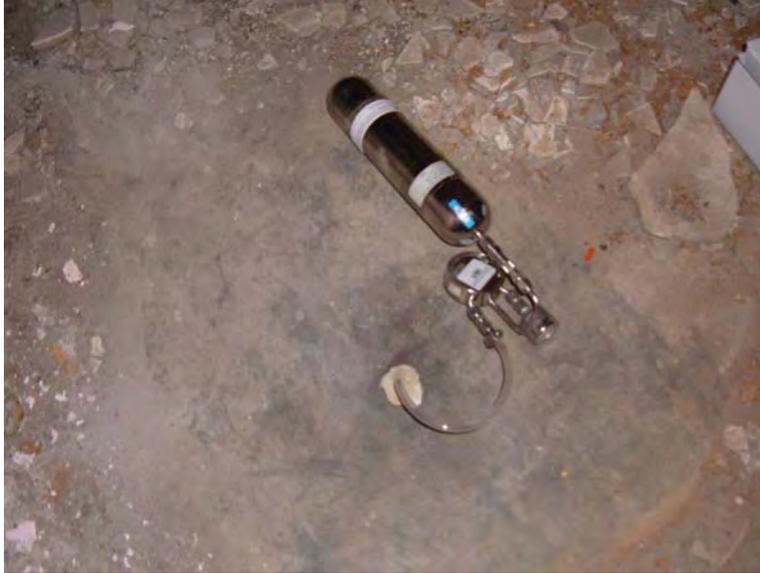
Location: View of sub-slab sample SS-1 in the northwest corner of the basement.

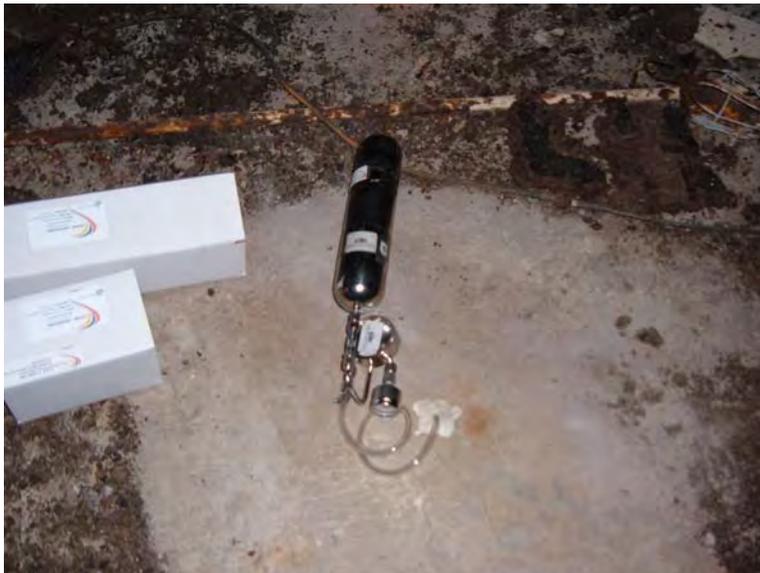
Photo Number #2

Location: View of sub-slab sample SS-2 in the fur vault of the basement.

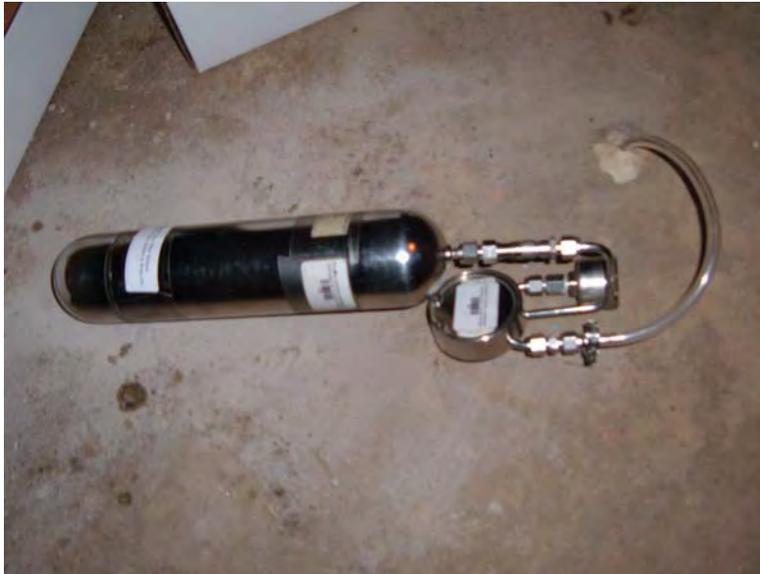
Photo Number # 3

Location: View of sub-slab sample SS-3 southern portion of the basement.

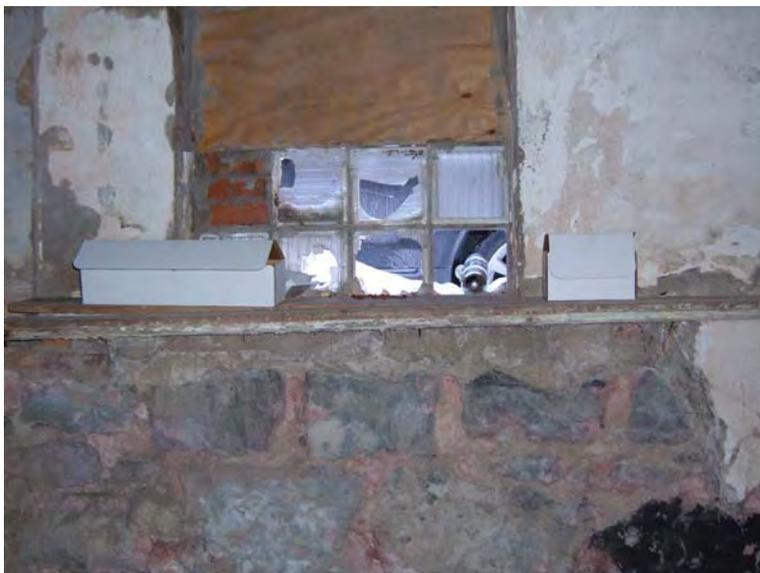
Photo Number # 4

Location: View of outdoor ambient air sample OA on the western side of the building, outside a first floor window.

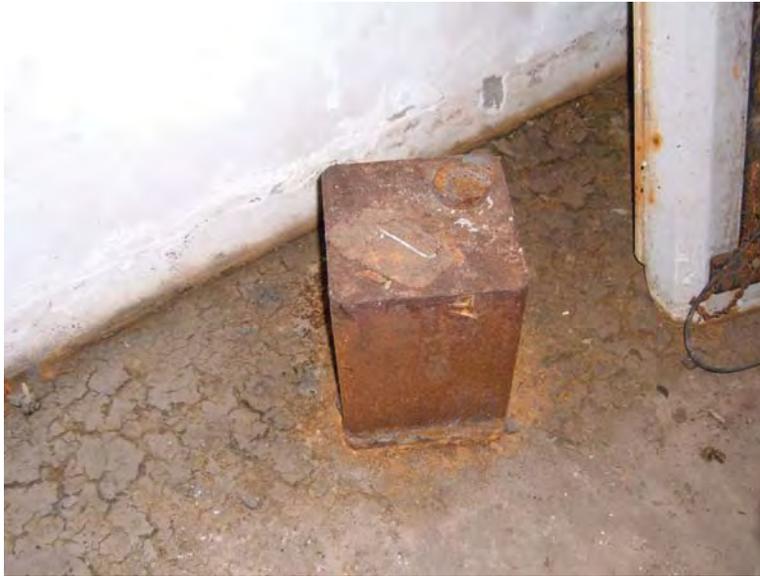
- Two (2) rusted, unlabeled metal containers with an approximate 3-gallon capacity each. Both containers' lids were rusted shut. No evidence of leaks or spills was observed. No PID readings were registered near the containers;
- Five (5) yellow, plastic containers with an approximate 3-gallon capacity each. One of the containers was closed and contained a label indicating that the original substance of the container was soy bean oil. The other four containers were cut open or damaged. No evidence of leaks or spills was observed. No PID readings registered near the containers, and;
- One (1) plastic container with an approximate 3-gallon capacity was damaged and contained a label indicating that the original substance of the container was salad oil. No evidence of leaks or spills was observed. No PID readings registered near the container.

Location: View of an unlabeled, rusted container near sub-slab sample SS-3.

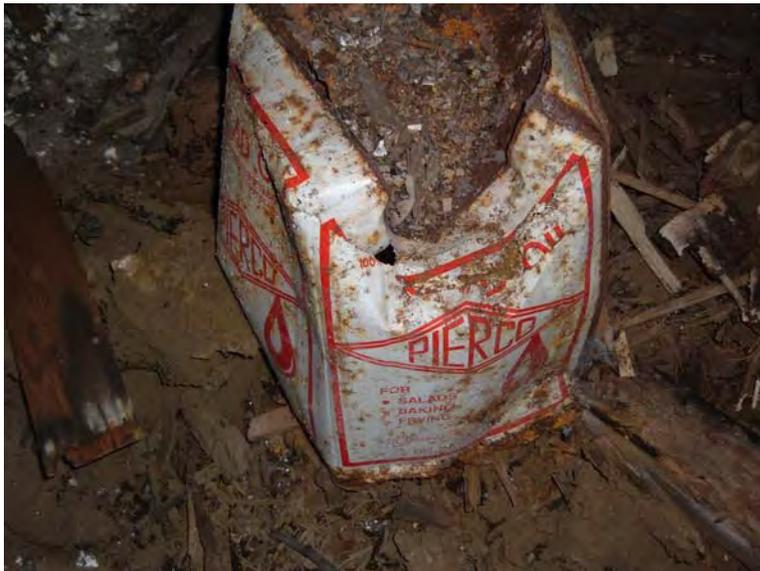
Photo Number # 6

Location: View of the salad oil container observed near sub-slab sample SS-3.

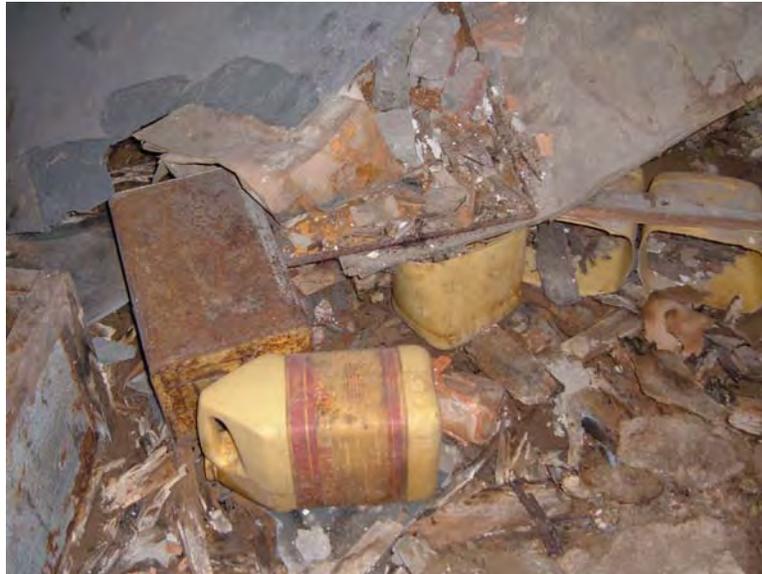
Location: View of containers near sub-slab sample SS-3. The yellow containers were labeled as soy bean oil.

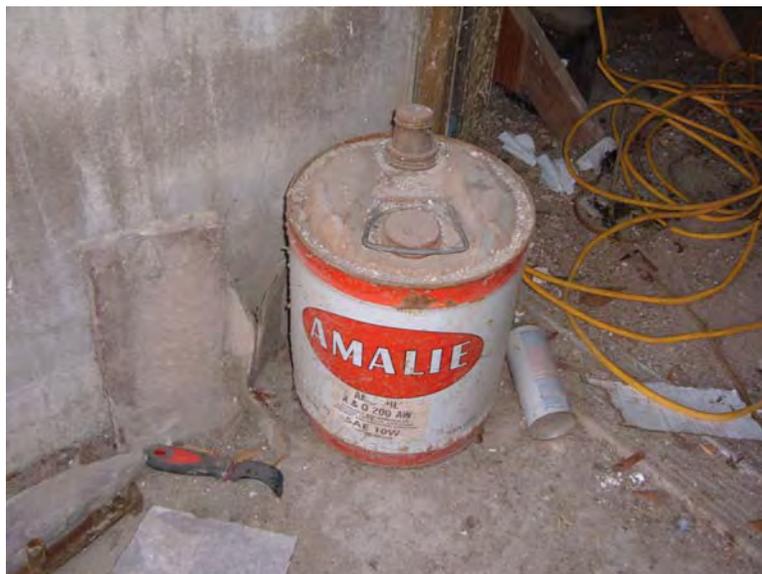
Photo Number # 8

One (1) metal container, labeled hydraulic oil, was stored immediately inside the front entrance of the building. It was closed and no evidence of leaks or spills was observed. No PID readings registered near the container.

Location: View of the hydraulic oil container on the first floor, near the front entrance.
