Phase I Environmental Site Assessment

**42 Wadsworth Street
Auburn, New York**

CHA Project Number: 23348

March 12, 2012

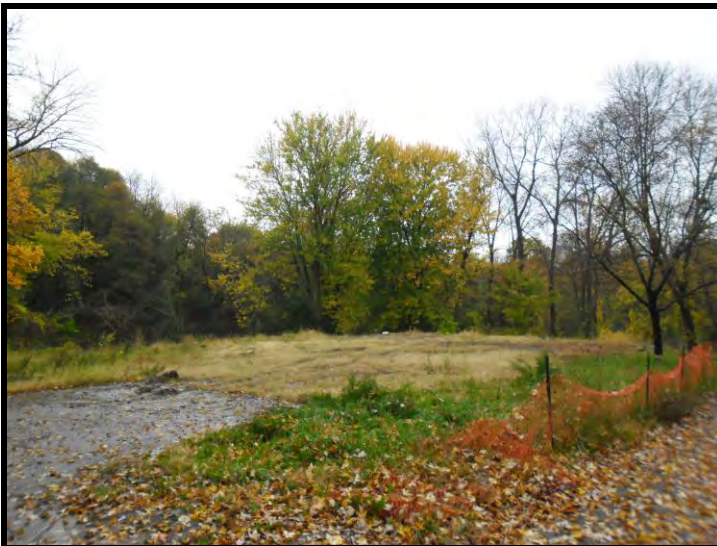
Photograph 1. Fill area at the western end of Wadsworth St.

CHA notes that at the time of the site reconnaissance it appeared that a structure had been demolished just south of the end of Wadsworth Street. Orange construction fence was present and fill appeared to have been brought in. Additionally, evidence of previously existing structures including concrete foundations and concrete block and a concrete pad were observed on the Property.

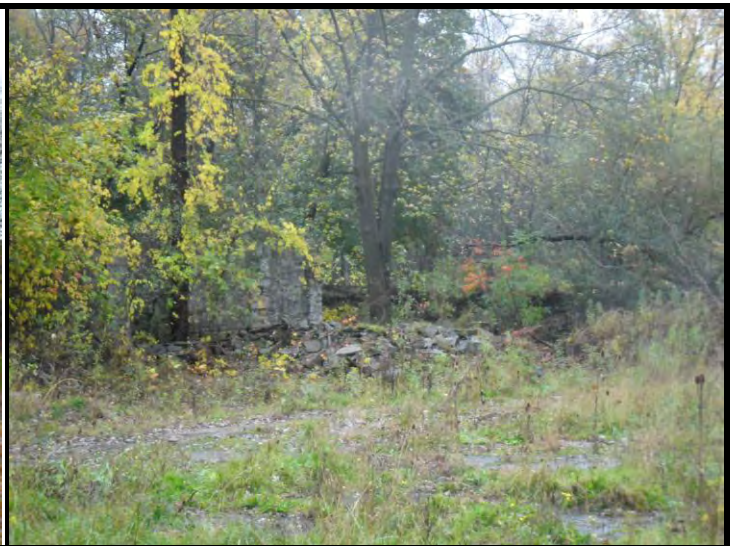
Photograph 2. Building remnants on the Property.

It is known that structures were demolished on the Property. These structures were constructed prior to 1980 and it is unknown whether hazardous building materials surveys and/or abatement techniques were used prior to building demolition, therefore the potential exists for asbestos containing materials and/or lead based paint to be present within the demolition debris. Only concrete and brick debris was noted during the site reconnaissance, however additional materials could be buried on-site. No survey or sampling was performed as part of this phase I ESA.

As a result, CHA recommends that a limited subsurface investigation be performed on the Property including the areas within the former building footprints and the fuel oil houses.

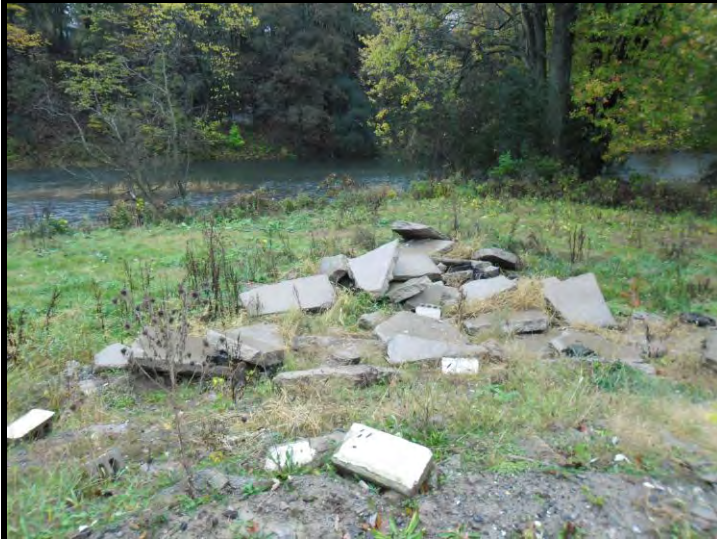
Photograph 3. Concrete debris on the Property.

been demolished on site. Asbestos containing materials were commonly used within structures of this era, therefore the potential exists for both materials to be present within any demolition debris which was buried on site. Only concrete debris was noted during the site reconnaissance, however additional materials could be buried on-site or present within the debris piles observed on the Property. No survey or sampling was performed as part of this phase I ESA.
